Manhole Inspection Summary

Manhole # S33CC_032MH

Insp Date: **3/1/07 11:17 AM**

Location Address: **1023 CATHEDRAL ST**

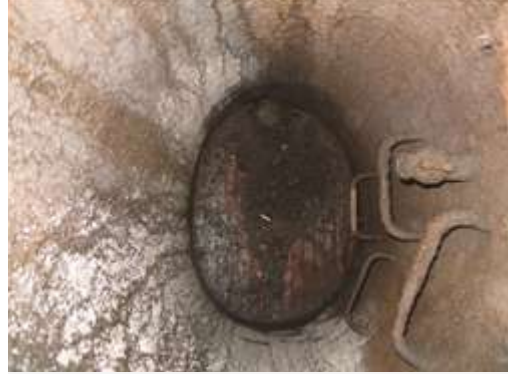
Top View

Channel debris. Corroded steps.

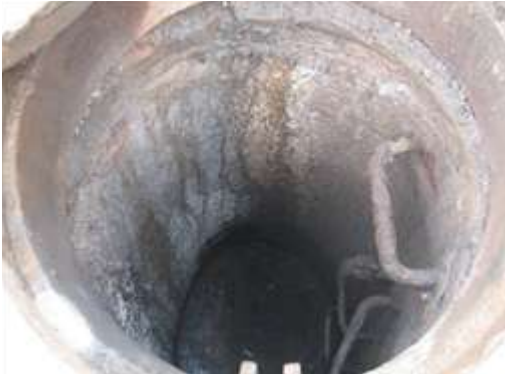
Defect

Frame leaks. Adjustment deterioration and infiltration. Barrel infiltration - other side.

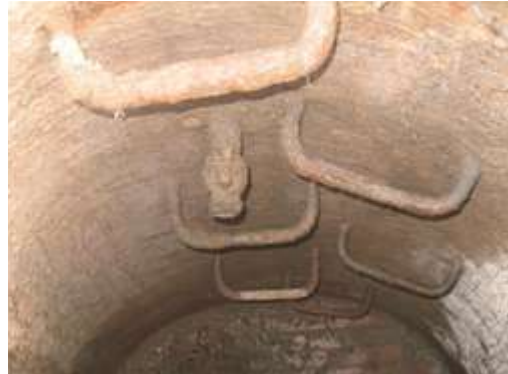
Defect

Corroded steps. Valve insert.

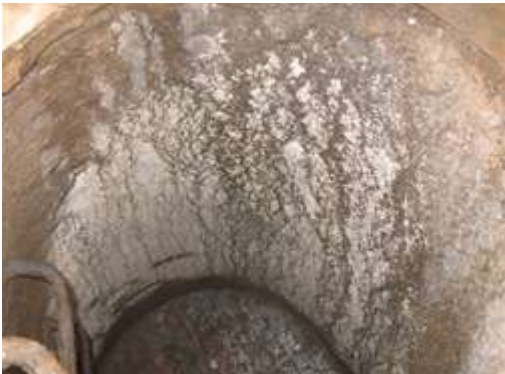
Defect

Frame leaks. Adjustment and Barrel infiltration.

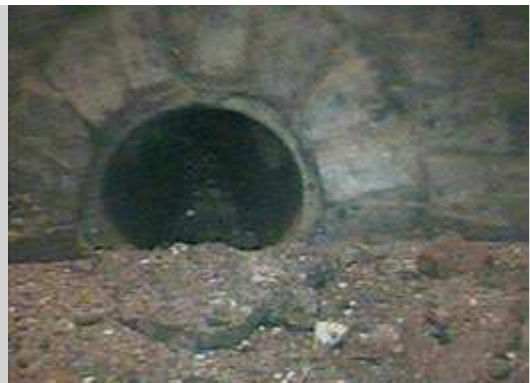
Pipe Out @ 12 O'Clock

8 in. Circular Gravity Sewer

Deposits: ☐ None ☒ **Mud** ☐ Sludge ☒ **Debris** ☐ Grease

Infiltration: **Evidence**
